# Manhole Inspection Summary

Manhole # S67E\_\_007MH

Page 1 of 3

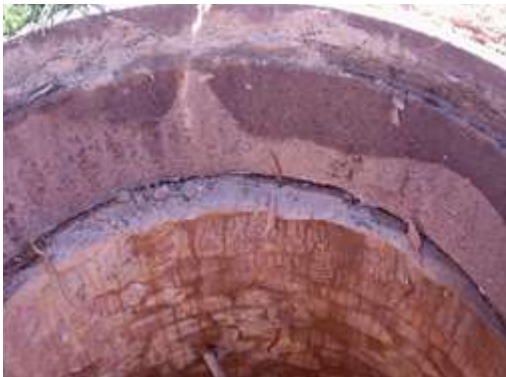
Defect 1

☒ **Leaks**

Frame Leaks

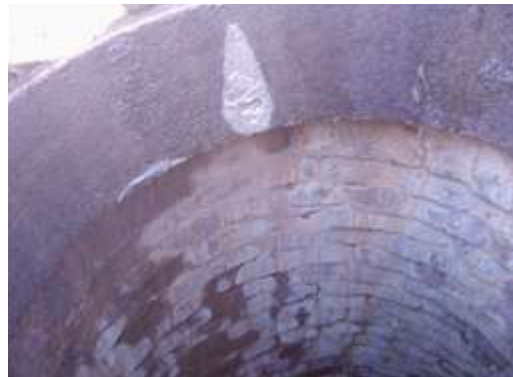
Defect 2

Infiltration: ☐ None ☒ **Joint** ☐ Cracks ☐ Mortar ☐ Roots ☒ **Wall**

Adjustment Joint

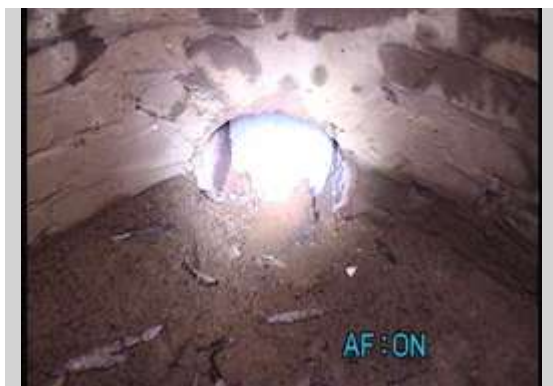
12 O'Clock Outflow

8 in. Circular Gravity Sewer  
Pipe Out @ 12 O'Clock

Deposits: ☒ None ☐ Mud ☐ Sludge ☐ Debris ☐ Grease

Infiltration: **None** Pipe Seal Cond: **Sound**
